COLLISION REPAIR INFORMATION

TITLE: BODY SECTIONING

SECTION: EXTERIOR BULLETIN #122

MODELS: ALL TOYOTA/LEXUS

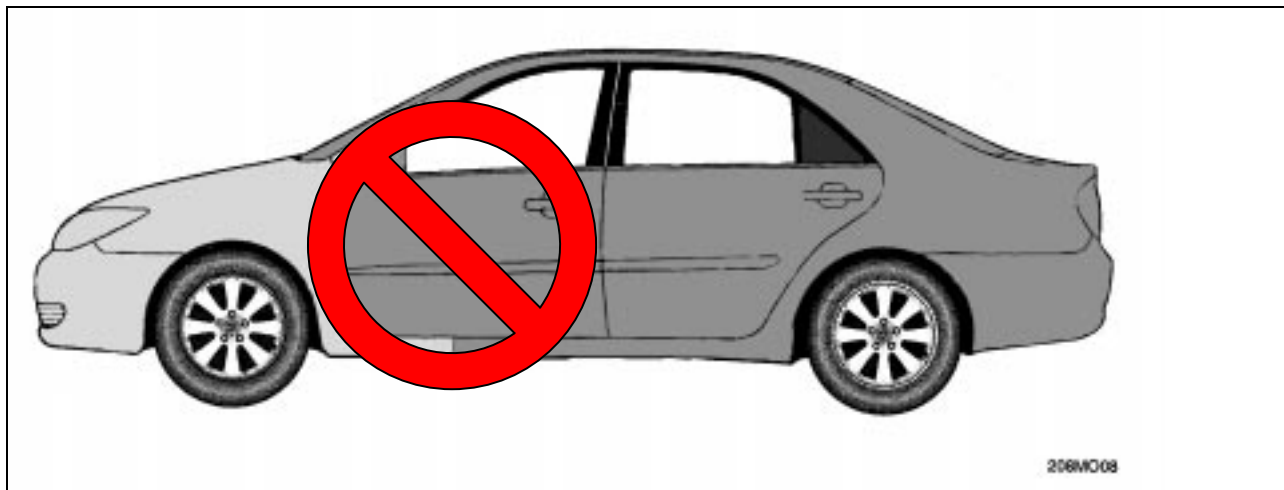
Full body sectioning, also known as “clipping” is **NOT** an approved repair procedure on any Toyota or Lexus vehicle.

Full body sectioning is generally done on a vehicle that has sustained severe rear end damage, where the front portion of one vehicle is joined to the rear portion of another vehicle.

Full body sectioning is **not approved** for the following reasons:

- Decrease in strength and safety from the original Toyota/Lexus design
- Poor fit and alignment of the body
- NVH (squeaks, rattles, etc.)
- Wind noises and water leaks
- Diminished protection from rust/corrosion

Always refer to the Toyota/Lexus model-specific repair manual for approved cut/join locations, measurements, welding requirements, and other important information.
